**API-653**  
**Tank Inspection**  
**Sample Report**

This tank is an approximately 210k-gallon vertical aboveground storage tank, reportedly fabricated of carbon steel in 1970, by Tank Manufacturer, Inc. The tank is approximately 30' diameter by 40' high, and is mounted on a concrete foundation.

<b>NOVA DATA TESTING SERVICES, INC.</b> (912) 729-3895	ICN K0000	LOCATION Lotsa Power, Inc. Somewhere, USA	EQUIPMENT Big Tank #2 Tank - Shell	DATE(S) OF INSPECTION 01/01/2005
	REPORT DATE 01/01/2005			DRAWING NUMBER K0000-D-01

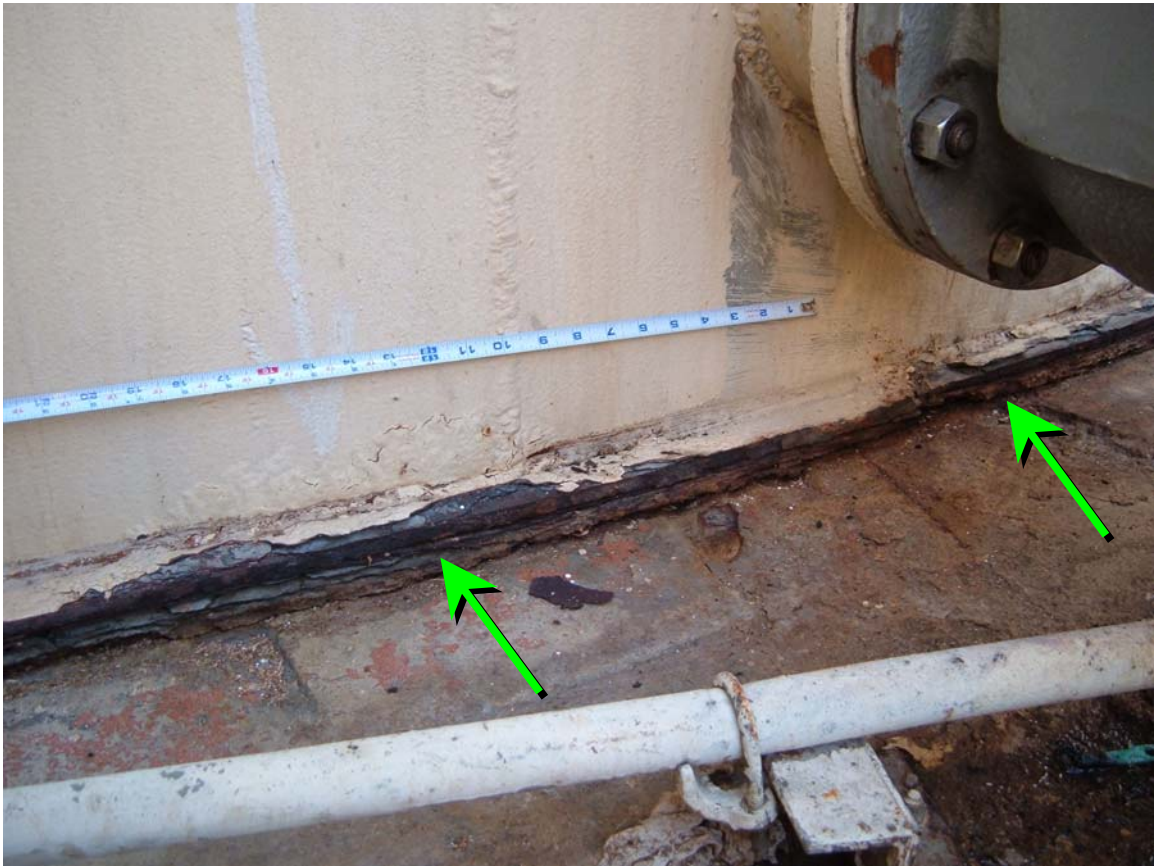
**Floor** – Major scale corrosion on floor protrusion, however, does not exceed minimum wall. Vacuum box inspection was performed on 100% of floor seam welds and floor-to-shell weld. No relevant indications were found at the time of inspection. Please refer to drawing K0000-D-01 for all ultrasonic thickness values and locations on the floor. Thickness forecasting of the floor shows a life expectancy of at least 10 years.

Fig. 1 – Major scale corrosion of floor protrusion

1. Sandblast and apply protective coating
2. Remove shell patches and repair shell in accordance with API-653
3. Seal tank floor protrusion to concrete foundation interface after repairs, to prevent moisture from migrating under the tank
4. Perform radiographic weld inspections of non-rounded shell inserts and non-conforming weld seams, as indicated above
5. Install reinforcing plate around 8” penetration on lower west side of tank

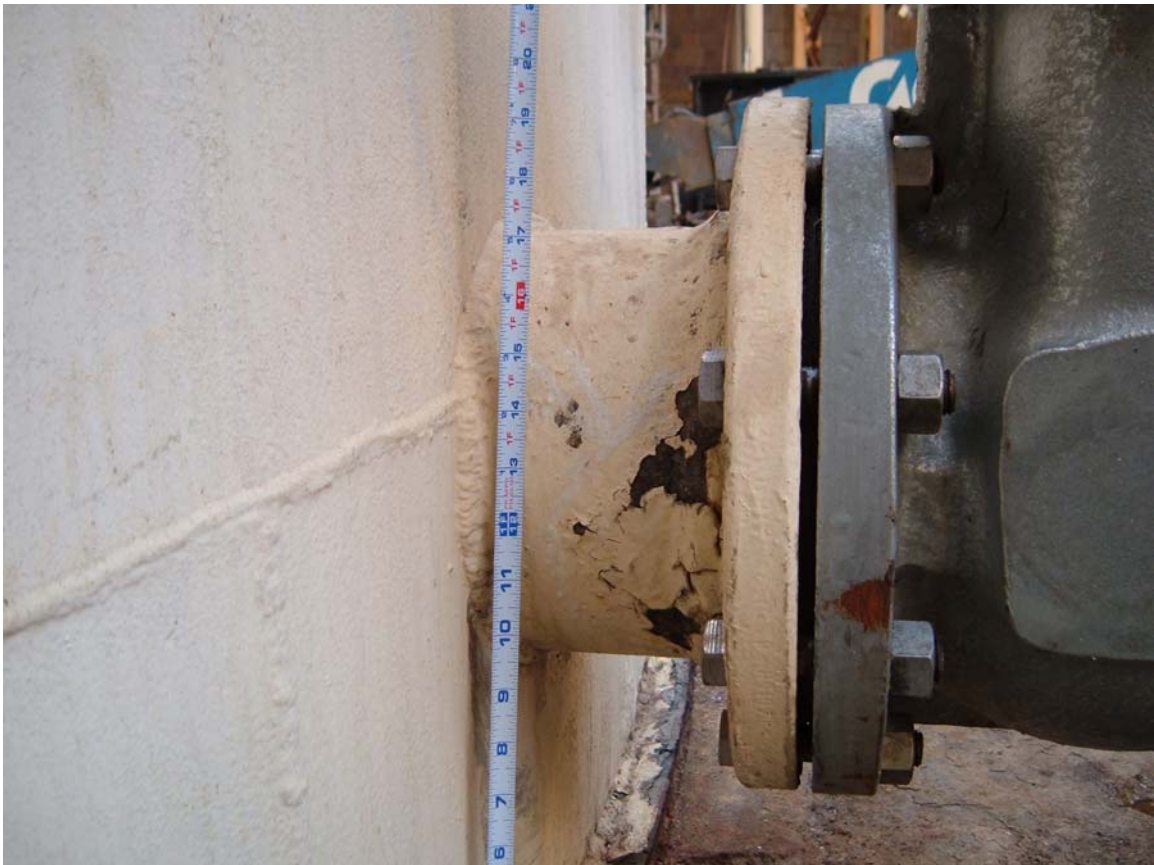
Fig. 2 – Penetration with no reinforcing plate

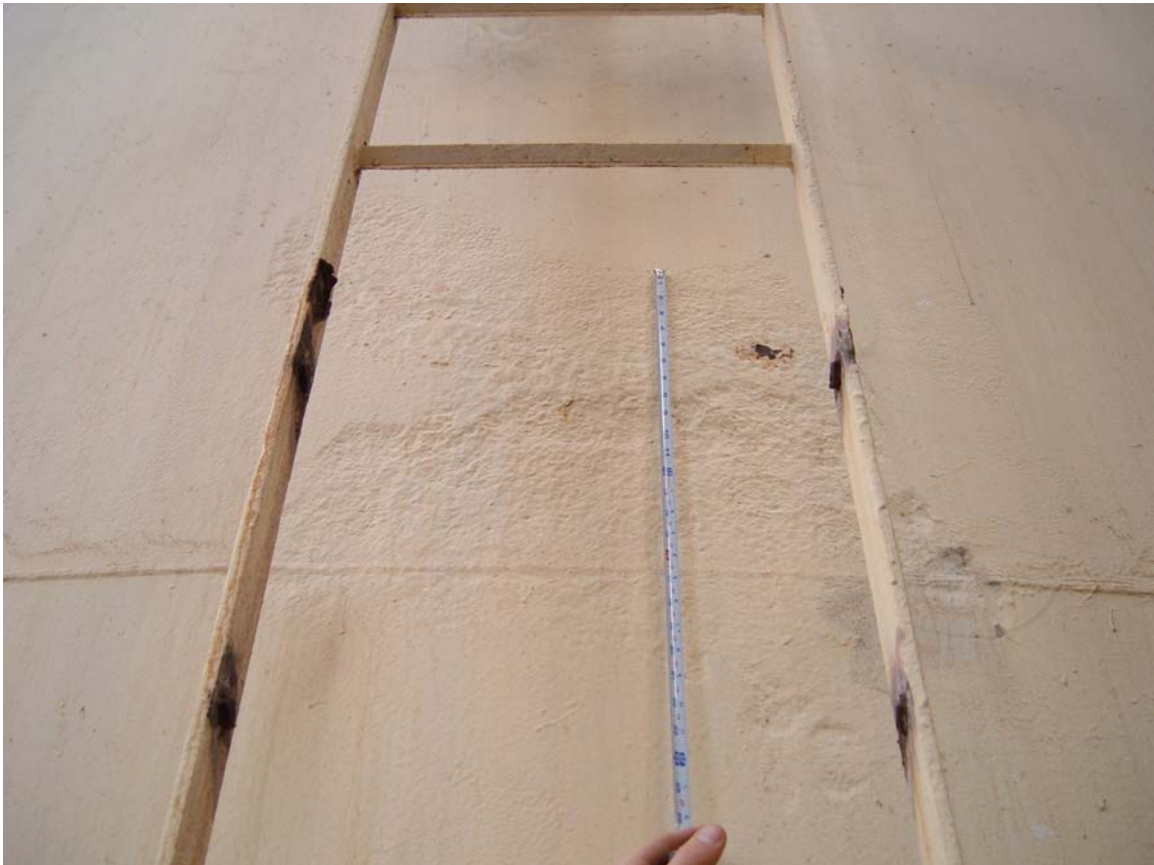
**Pitting** – Shell pitting does not exceed maximum allowable pitting per API-653. Multiple pitted areas noted on the third shell course with pits up to 0.120” deep. This pit depth subtracted from the nearest thickness measurement location, calculates a thickness of approximately 0.190” vs. a minimum wall calculation of 0.151”. Multiple gouges and temporary weld attachments on shell, not filled and ground smooth with base metal.

Fig. 3 – Major pitting on the third shell course, south side of tank

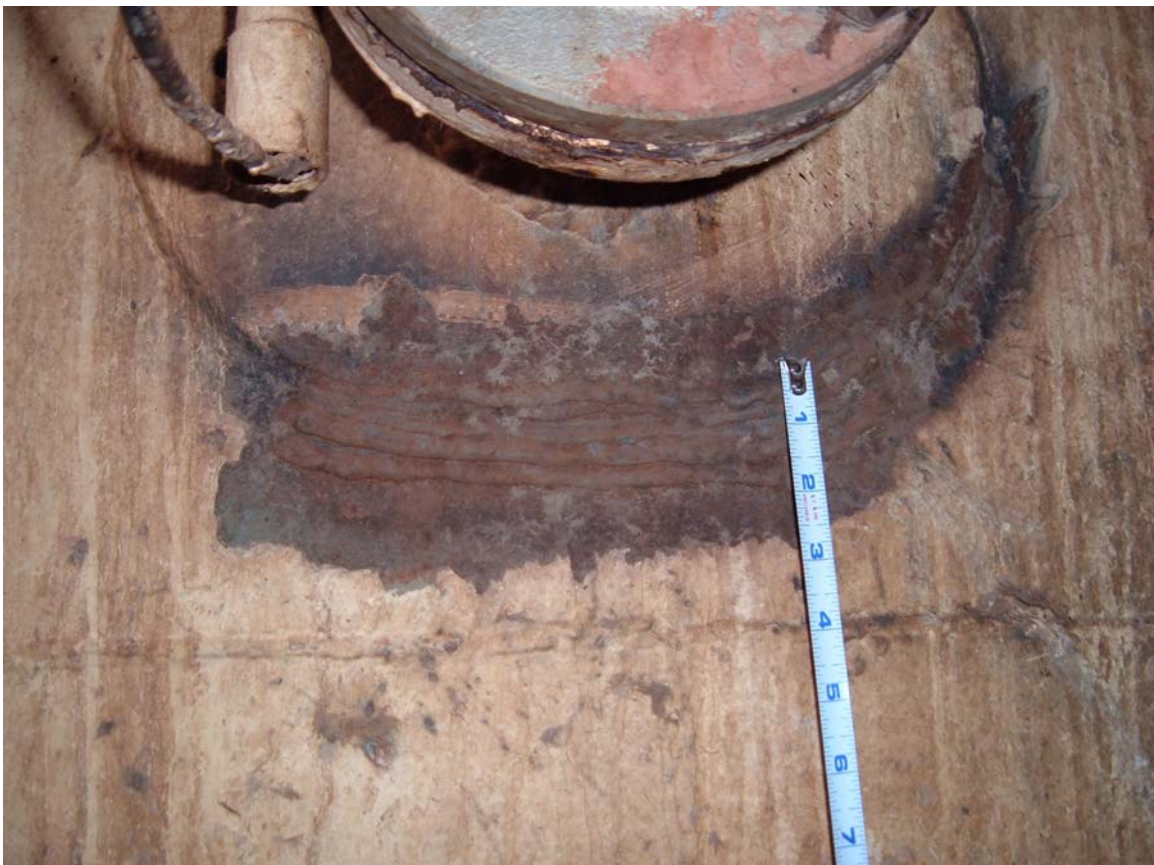
Fig. 4 – Poor and excessive weld on penetration reinforcing plate (East side)

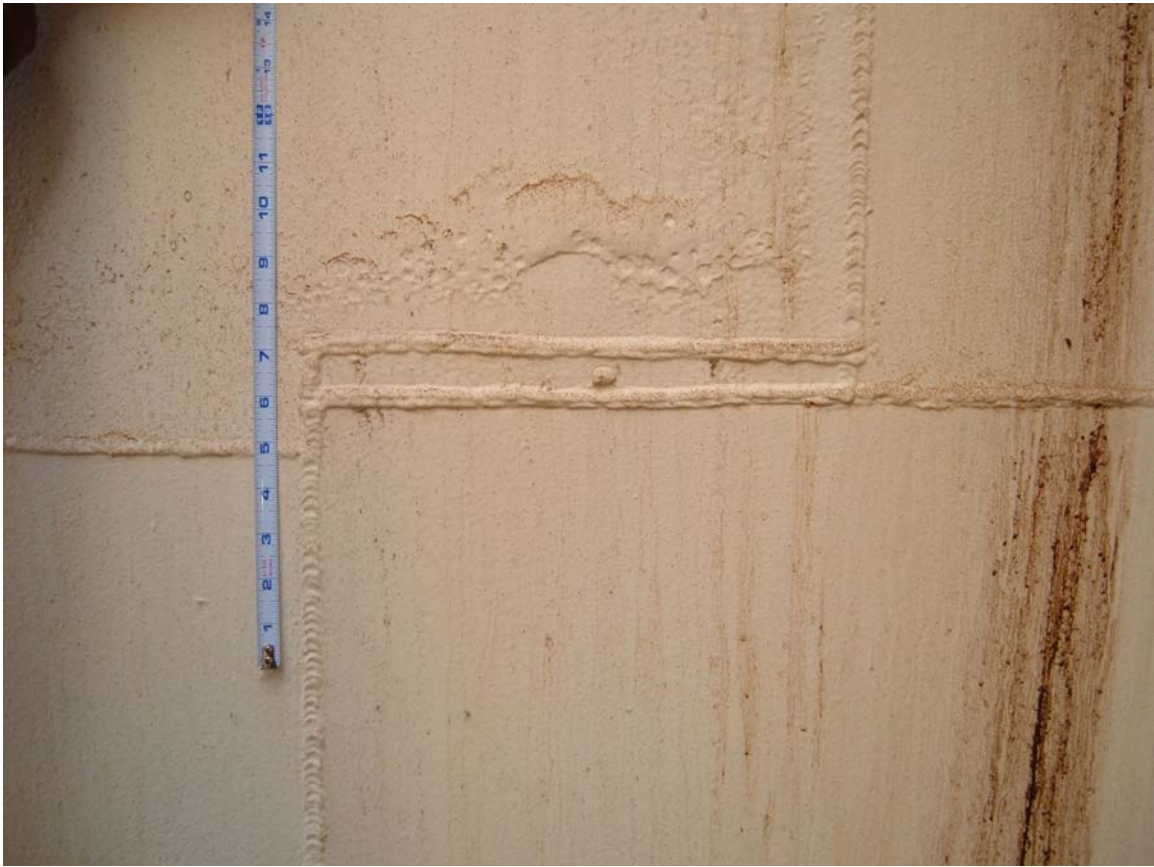
1. Shell course weld alignment and spacing on upper shell courses on the south side, does not meet API-650, section 3.1.5.3.b. (See drawing K0000-D-01, and Fig. 5 and 6)  
Recommend radiographic weld inspection to determine weld integrity and course of action (if any).
2. Penetration on west side of tank, on 1<sup>st</sup>-to-2<sup>nd</sup> shell course weld seam, has no reinforcing plate per API-650, section 3.7.2. (See P2 on drawing K0000-D-01, and Fig. 2)  
Recommend installing reinforcing plate per API-650
3. Multiple shell inserts with non-rounded corners does not meet API-653, section 9.2 and table 9.1. (See drawing K0000-D-01 and Fig. 9 and 10)  
Recommend radiographic weld inspection to determine weld integrity and course of action (if any).

Fig. 5 – Weld spacing does not meet API-650 or good engineering practices

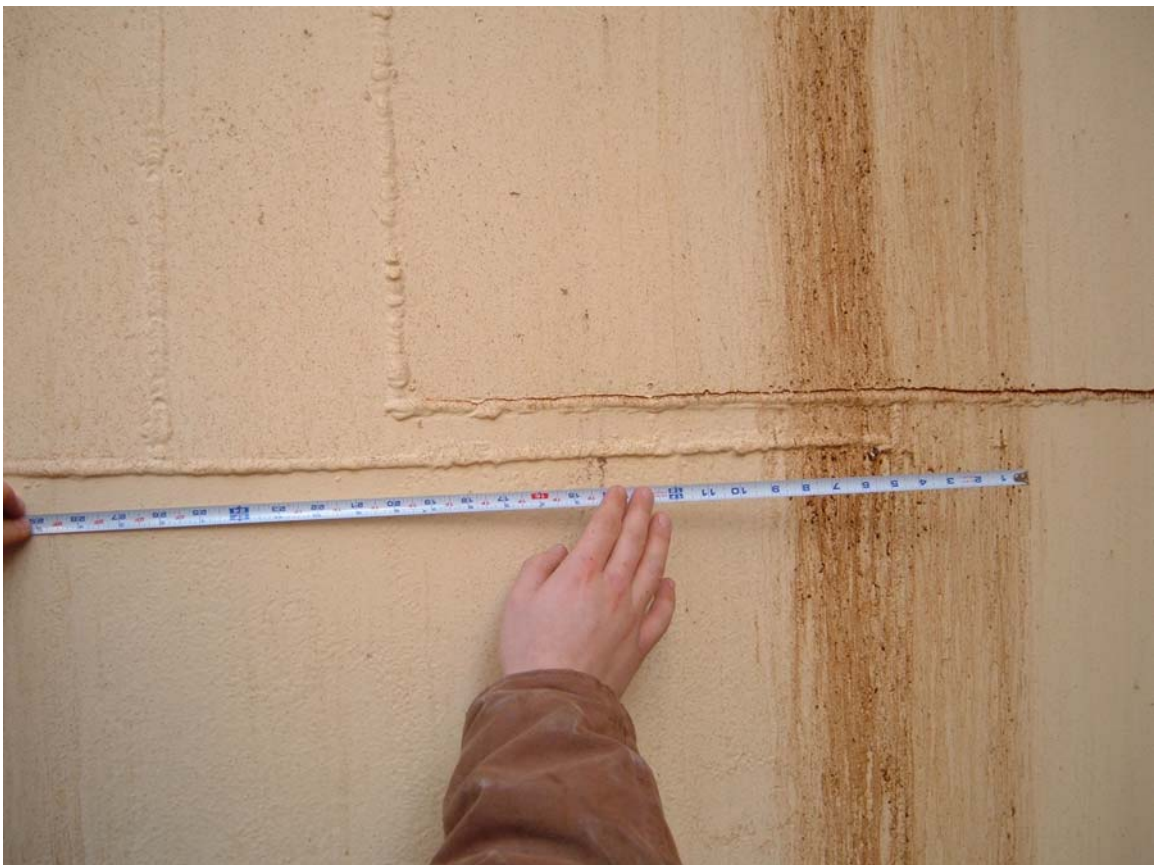
Fig. 6 – Weld spacing does not meet API-650 or good engineering practices

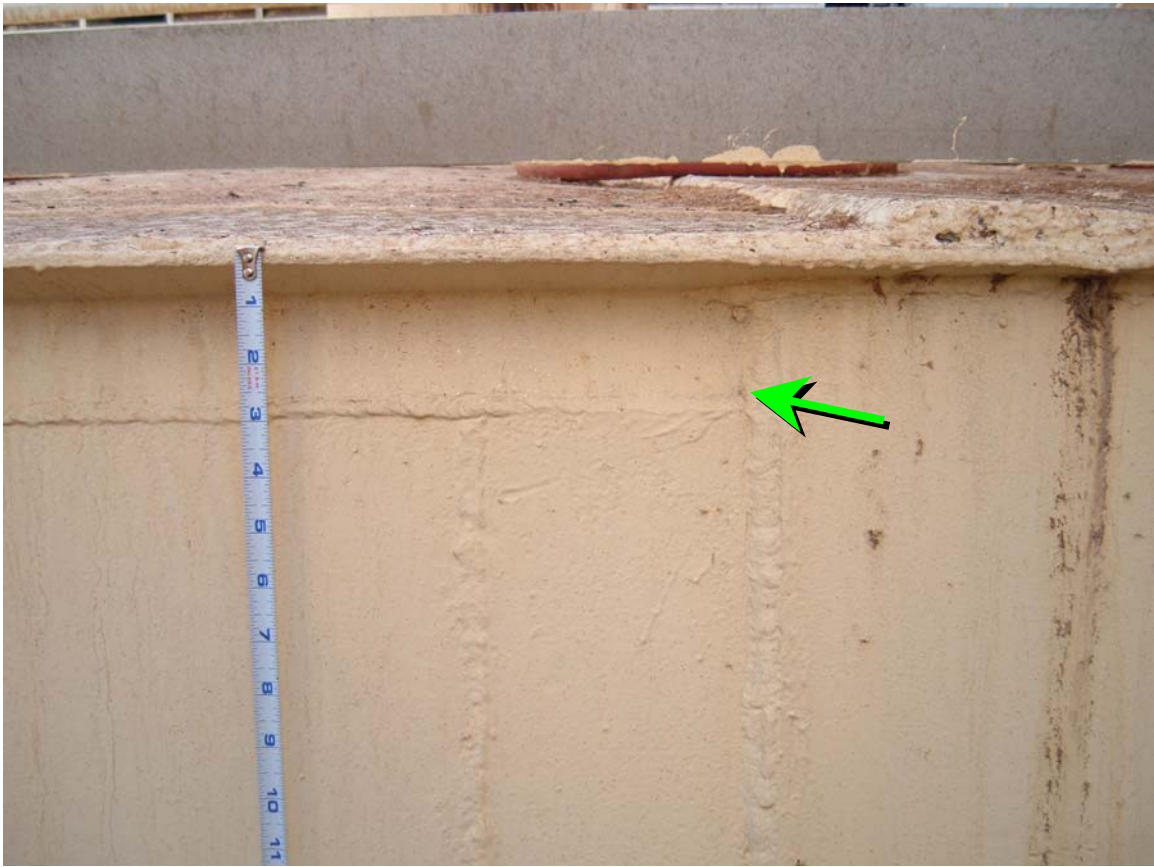
Fig. 7 – Shell plate misalignment near roof on the south side

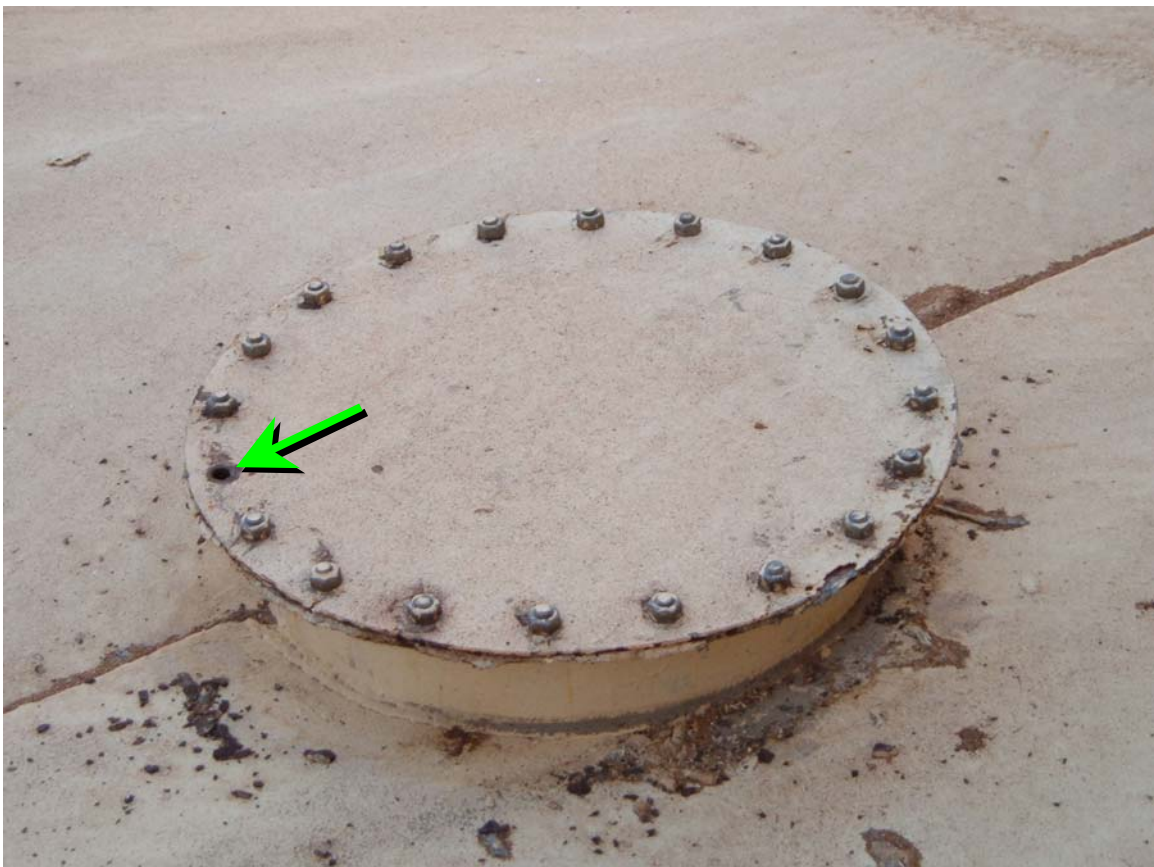
**Roof** – is not accessible due to major corrosion on access ladder. Inspection from manlift showed the roof to be in a serviceable condition. One bolt is missing from roof manway.

Fig. 8 – Roof manway is corroded and missing one bolt

1. Install missing bolt in roof manway
2. Sandblast and apply protective coating

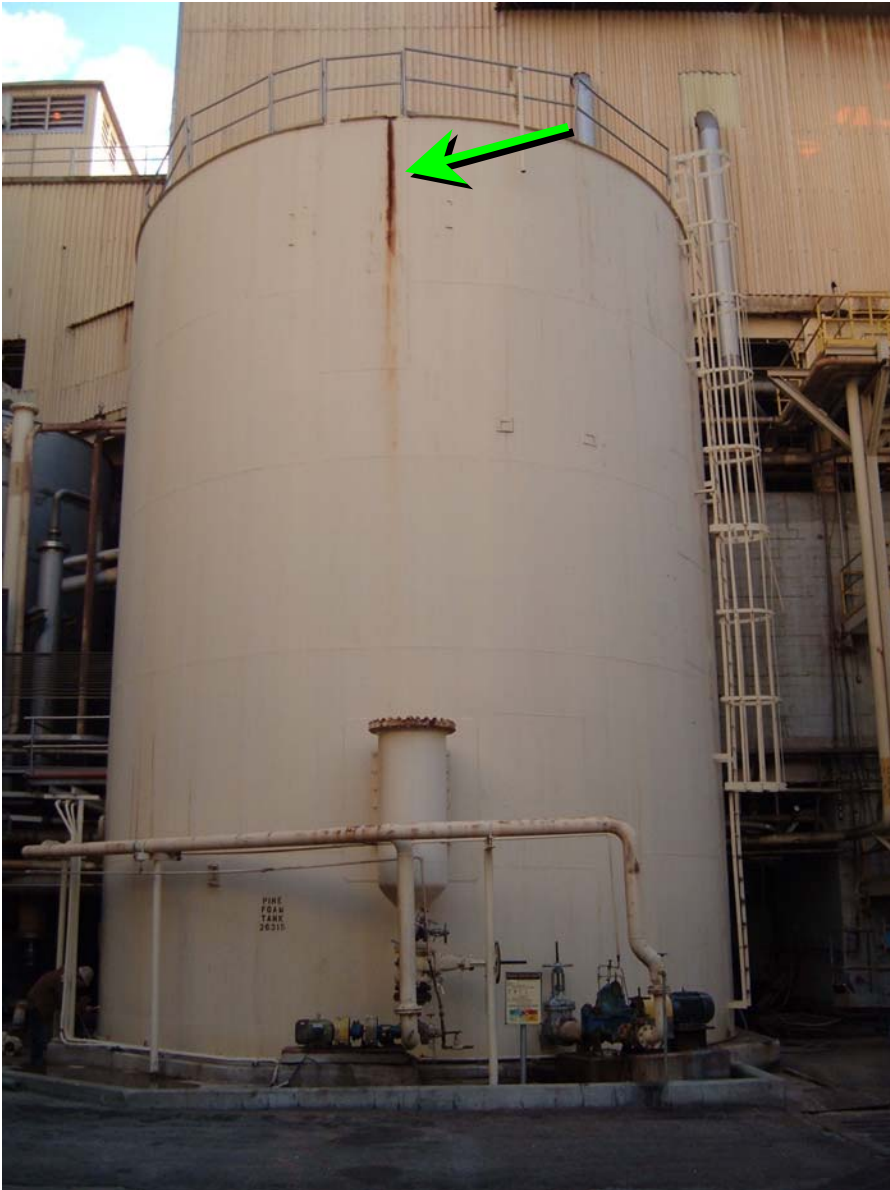
Fig. 9 – Corrosion on west side and multiple shell insert plates with non-rounded corners

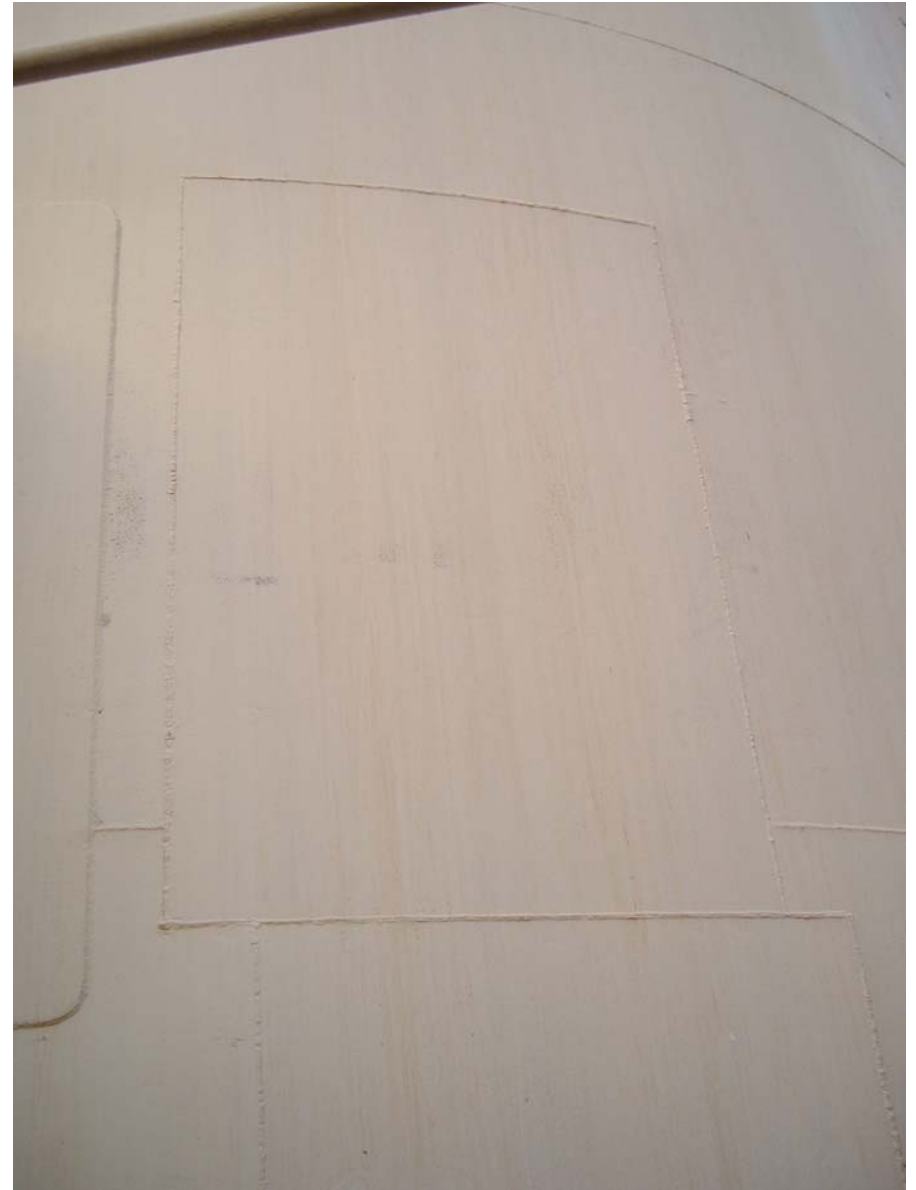
Fig. 10 – Typical shell insert plate with non-rounded corners

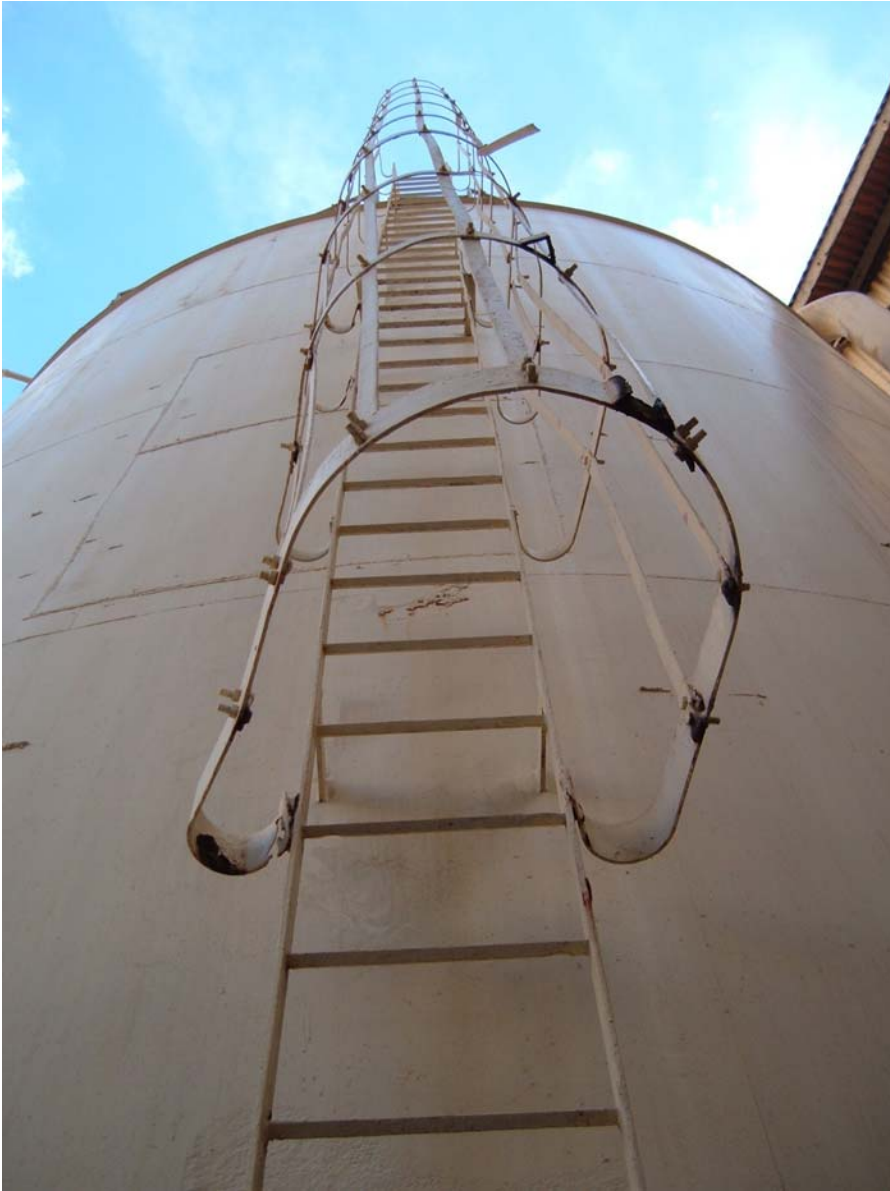
Fig. 11 – Major scale corrosion on ladder. Lower rungs have been removed to prevent access

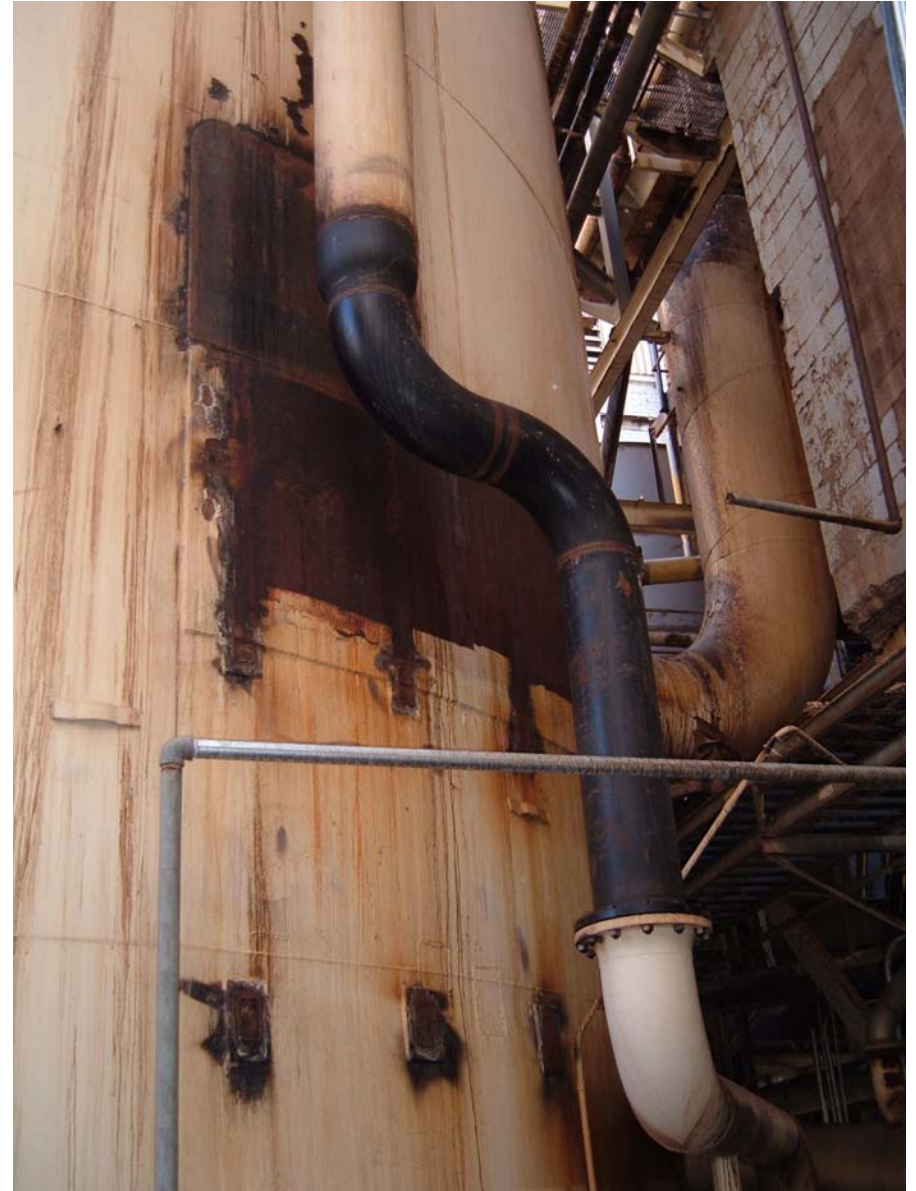
Fig. 12 – Multiple attachments with non-rounded corners, poor weld quality, and major corrosion (south-east side)

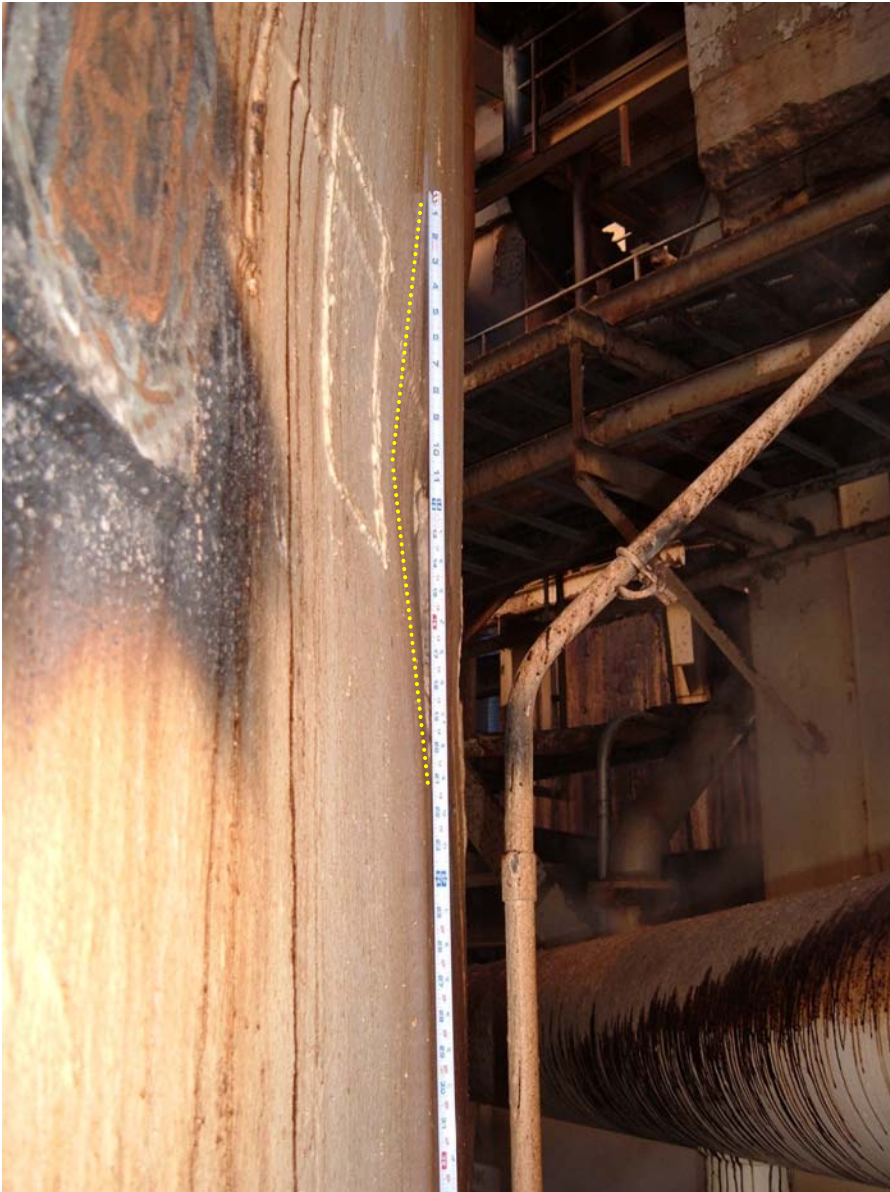
Fig. 13 – Minor shell deflection on upper second shell course (south-east side of tank)

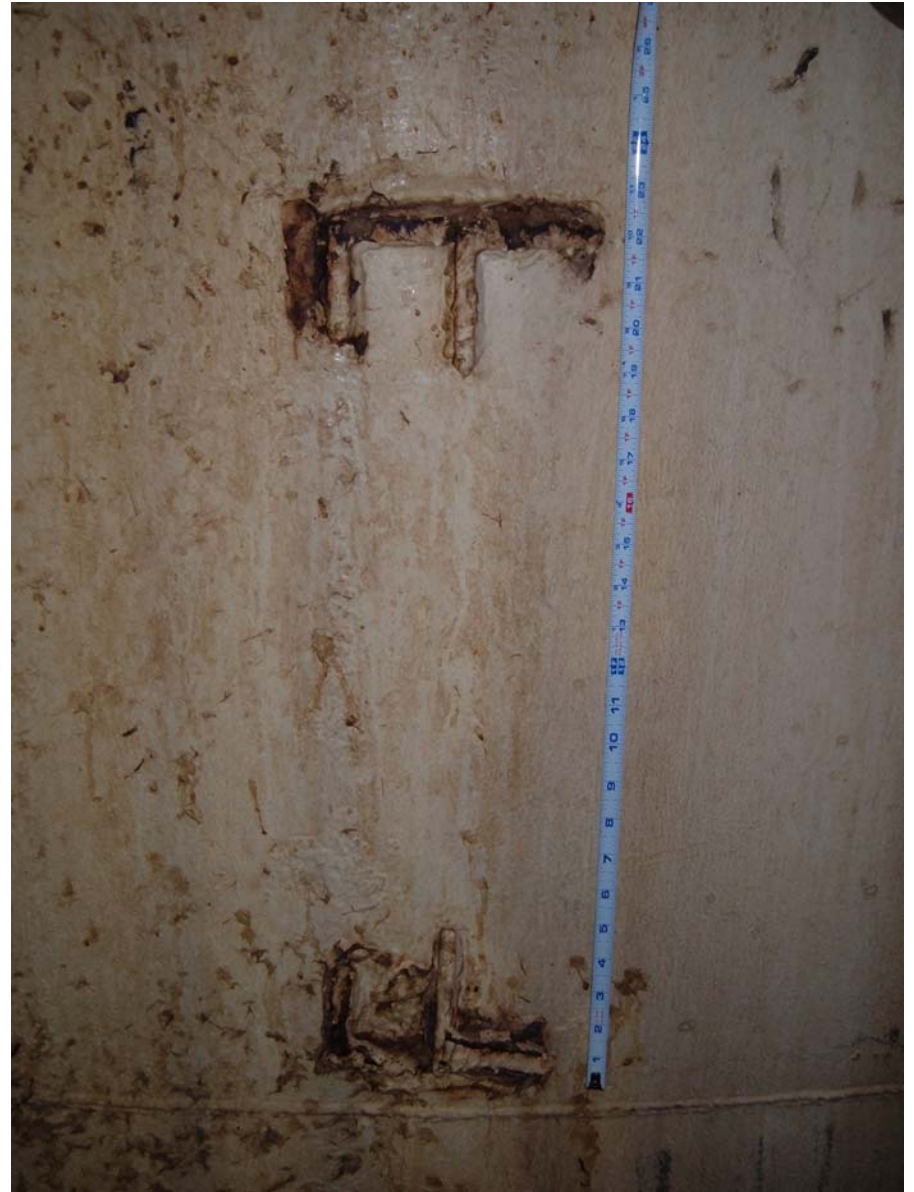
Fig. 14 – Attachments on lower second shell course on the east side of tank

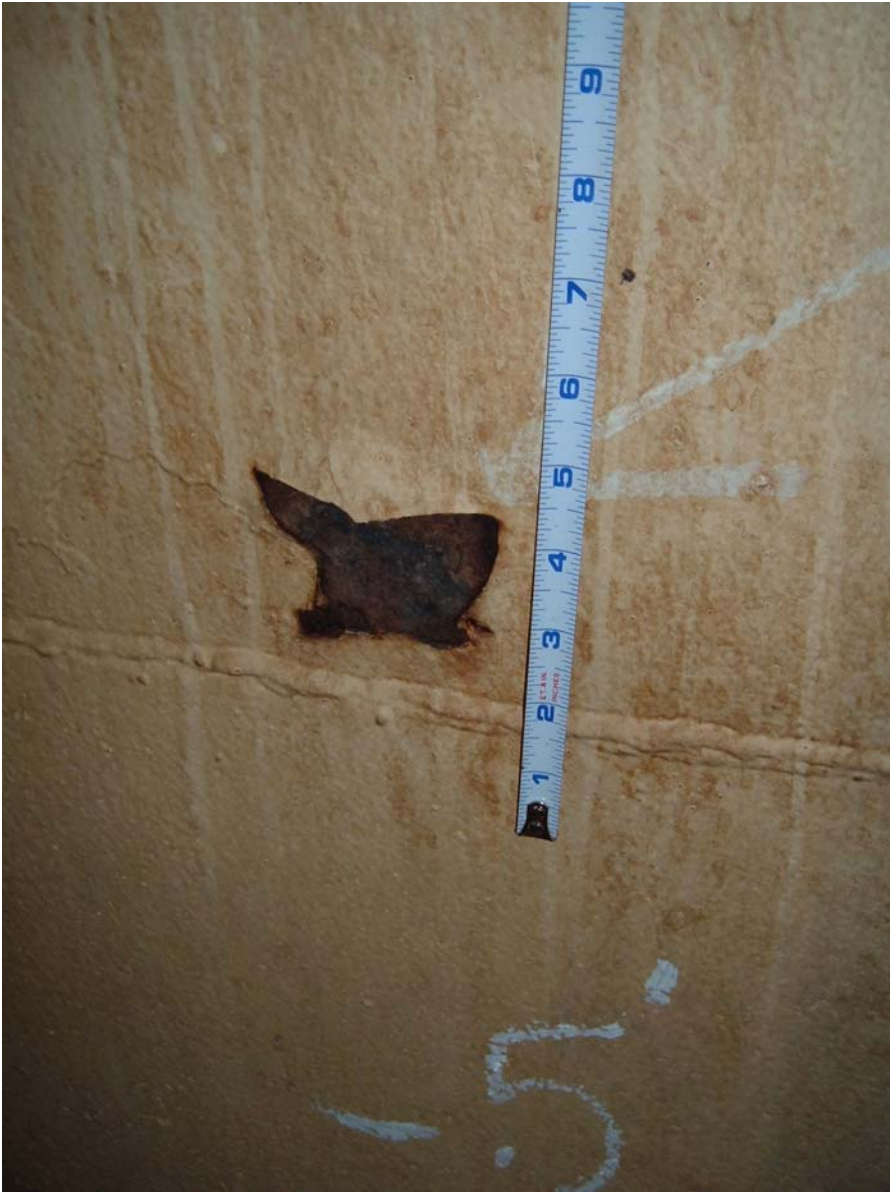
Fig. 15 – Isolated major corrosion on east side of lower second shell course

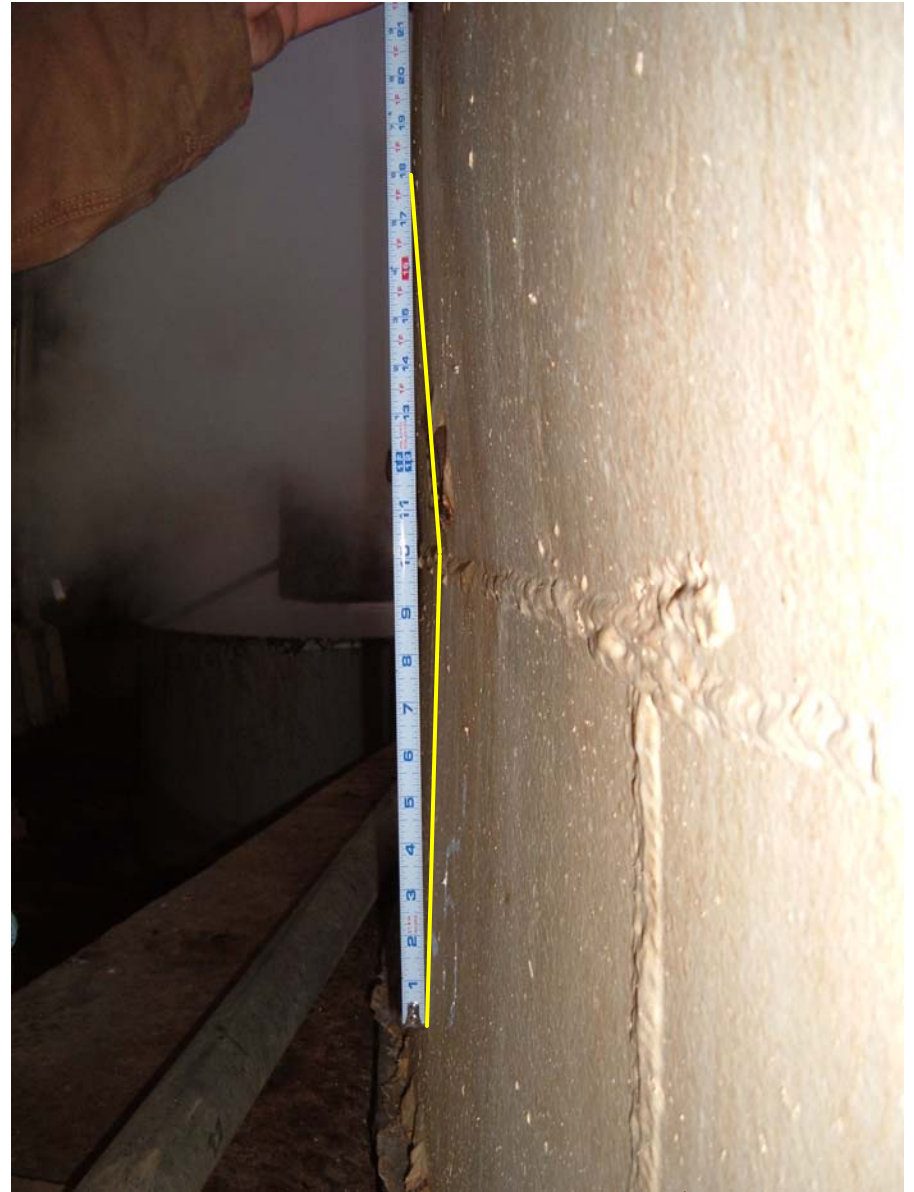
Fig. 16 – Minor shell deflection between 1<sup>st</sup> and 2<sup>nd</sup> shell course on east side of tank

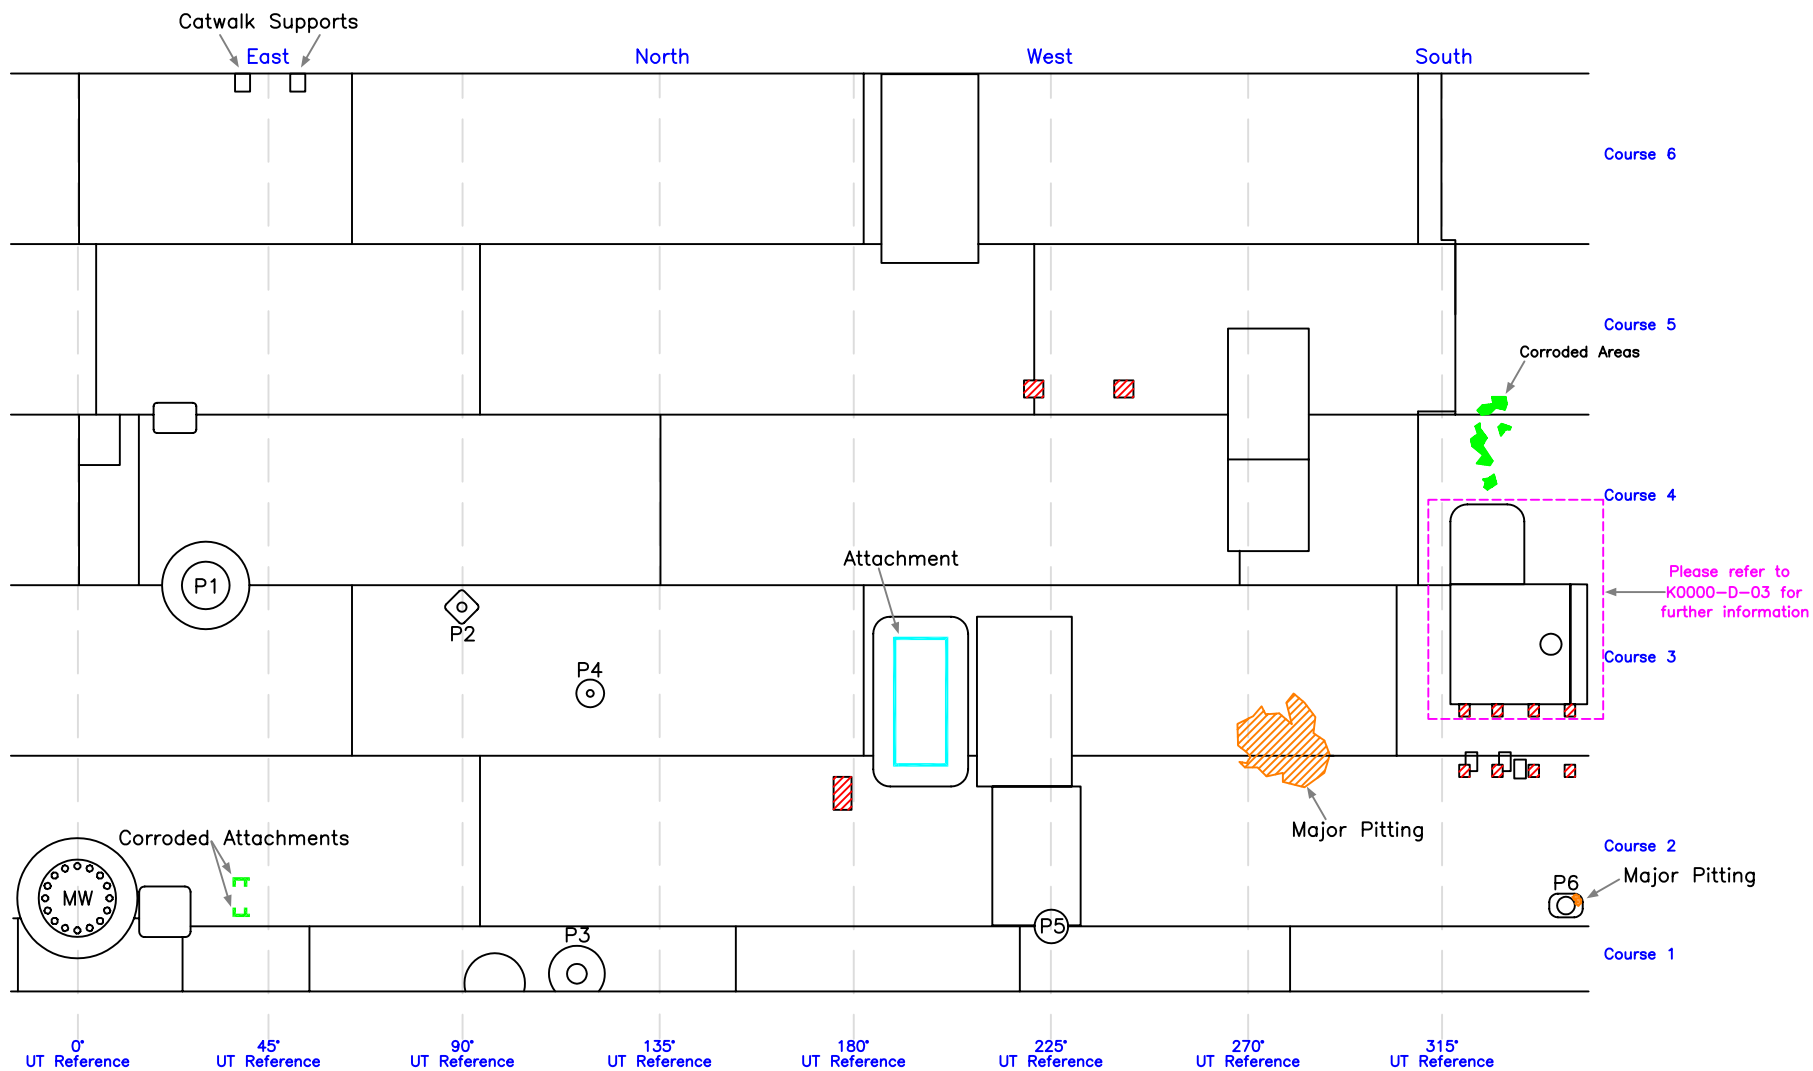
Red hatch indicates shell patch plates with non-rounded corners

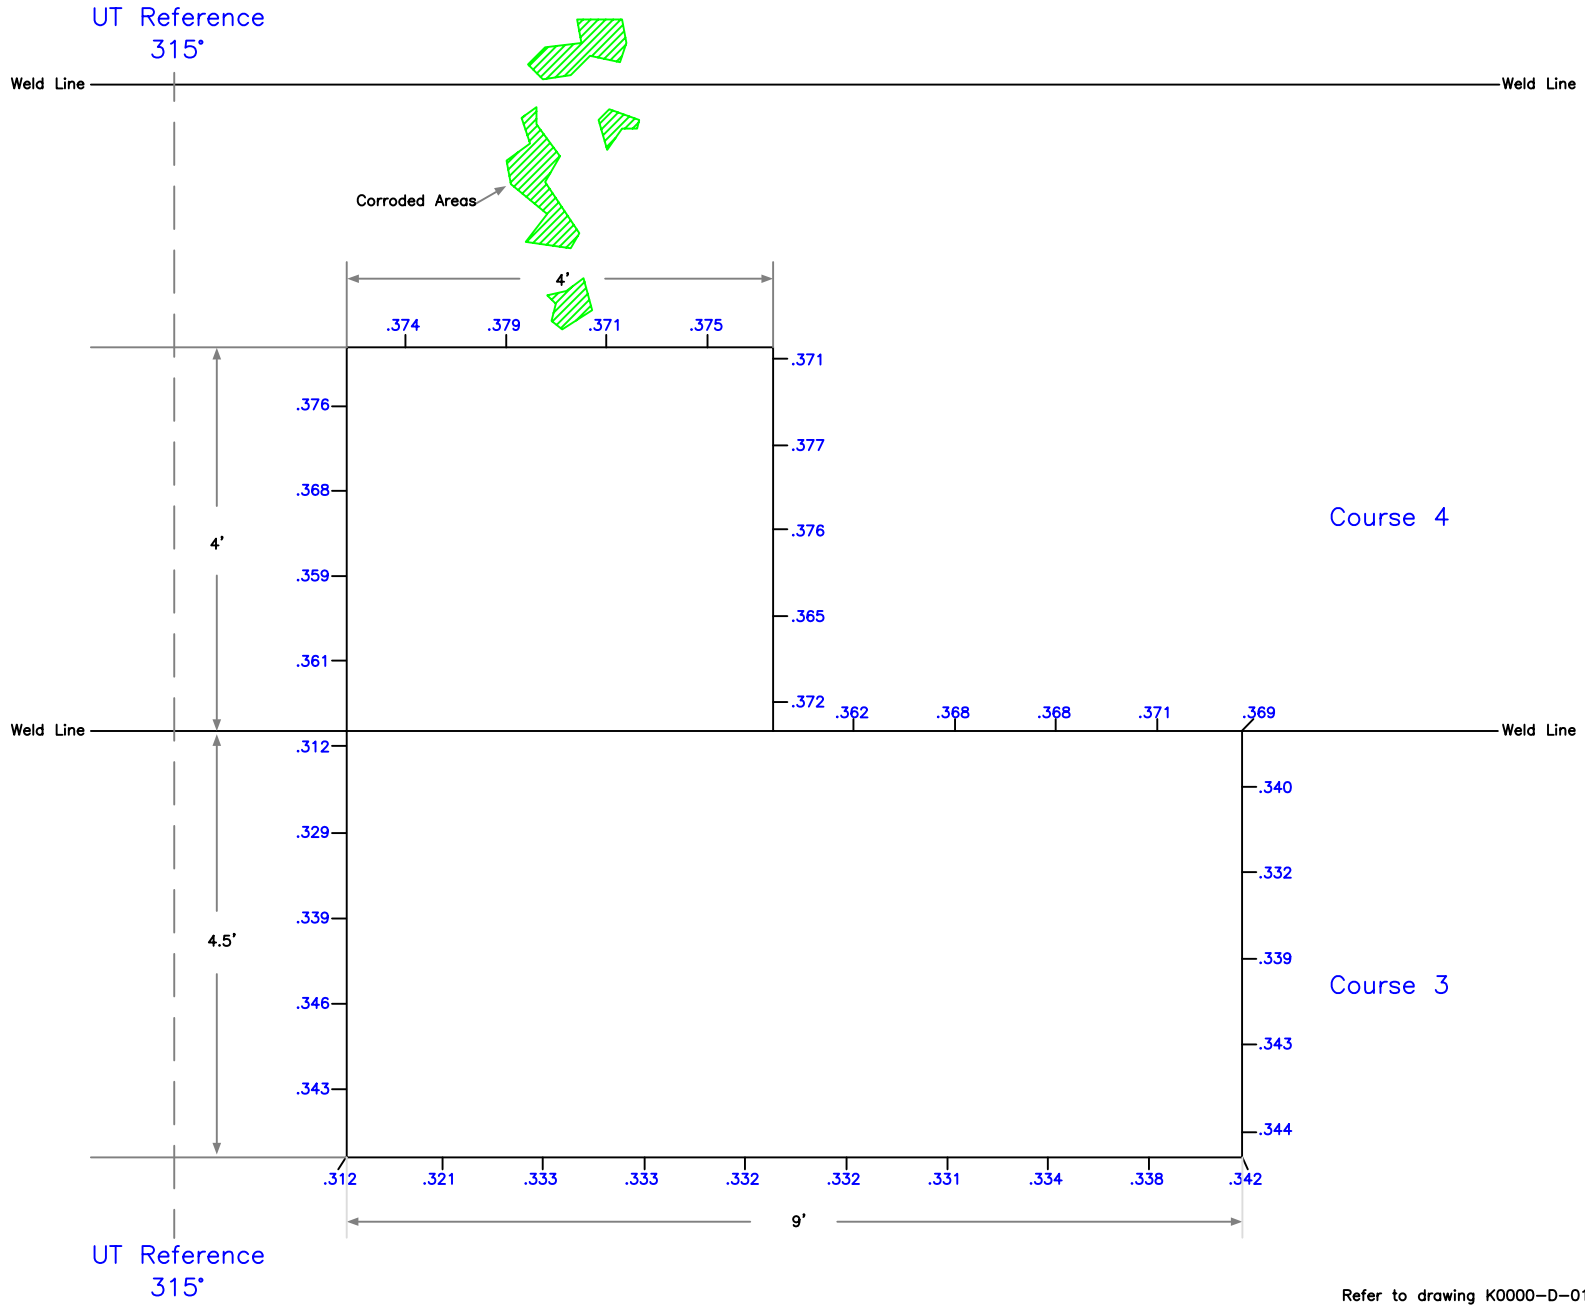
DATE(S) OF INSPECTION 01/01/2005  
DRAWING NUMBER K0000-D-03

Ultrasonic thickness readings were taken around external patch plates on the shell. Refer to drawing K0000-D-03 for thickness values, patch dimensions and locations. Corroded areas noted above patch plates that do not appear to affect the integrity at this time. Recommendations are to sand blast these areas and apply protective coating.
