**Paper Machine  
Dryer Inspection  
Sample Report**

**Machine Number:** 2  
**Dryer Diameter:** 48"  
**Nat'l Board No:** 1234  
**Year Built:** 1975

**Manufacturer:** Beloit  
**Shell Length:** 312"  
**Max. Oper. Press:** 150 PSI  
**Max. Oper. Temp:** 350 °F

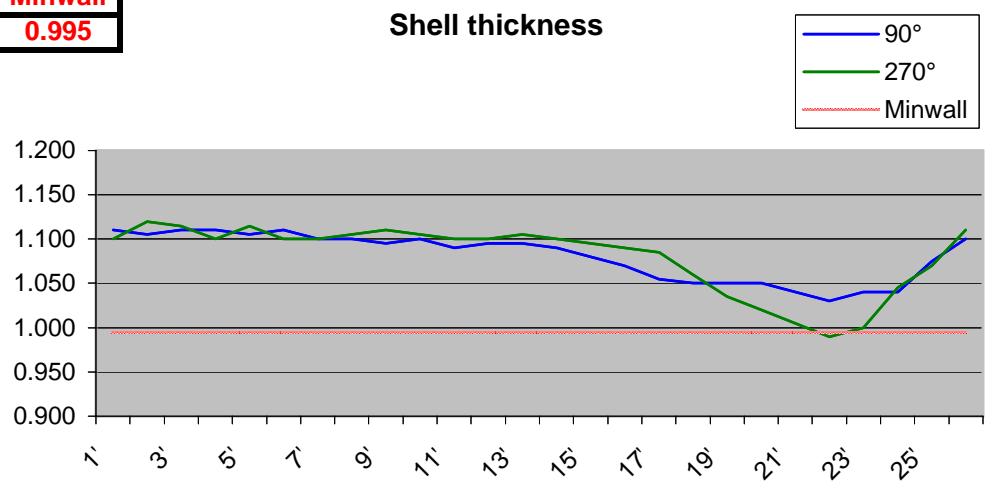
**Ultrasonic thickness inspection of shell:**

FT	90°	270°	Minwall
1'	1.110	1.100	0.995
2'	1.105	1.120	
3'	1.110	1.115	
4'	1.110	1.100	
5'	1.105	1.115	
6'	1.110	1.100	
7'	1.100	1.100	
8'	1.100	1.105	
9'	1.095	1.110	
10'	1.100	1.105	
11'	1.090	1.100	
12'	1.095	1.100	
13'	1.095	1.105	
14'	1.090	1.100	
15'	1.080	1.095	
16'	1.070	1.090	
17'	1.055	1.085	
18'	1.050	1.060	
19'	1.050	1.035	
20'	1.050	1.020	
21'	1.040	1.005	
22'	1.030	0.990	
23'	1.040	1.000	
24'	1.040	1.045	
25'	1.075	1.070	
26'	1.100	1.110

**Recommendations:**  
 Replace/re-rate dryer as necessary.  
 Replace tending side bolt #23

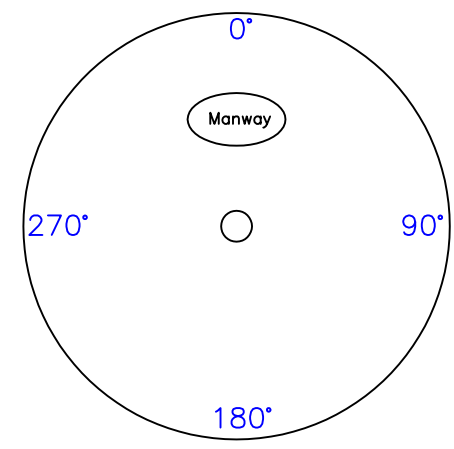
External View

**Ultrasonic soundness bolt inspection:** Indication on tending-side bolt #23.
