**Paper Machine  
Dryer Inspection  
Sample Report**

**Machine Number:** 2  
**Dryer Diameter:** 48"  
**Nat'l Board No:** 1234  
**Year Built:** 1975

**Manufacturer:** Beloit  
**Shell Length:** 312"  
**Max. Oper. Press:** 150 PSI  
**Max. Oper. Temp:** 350 °F

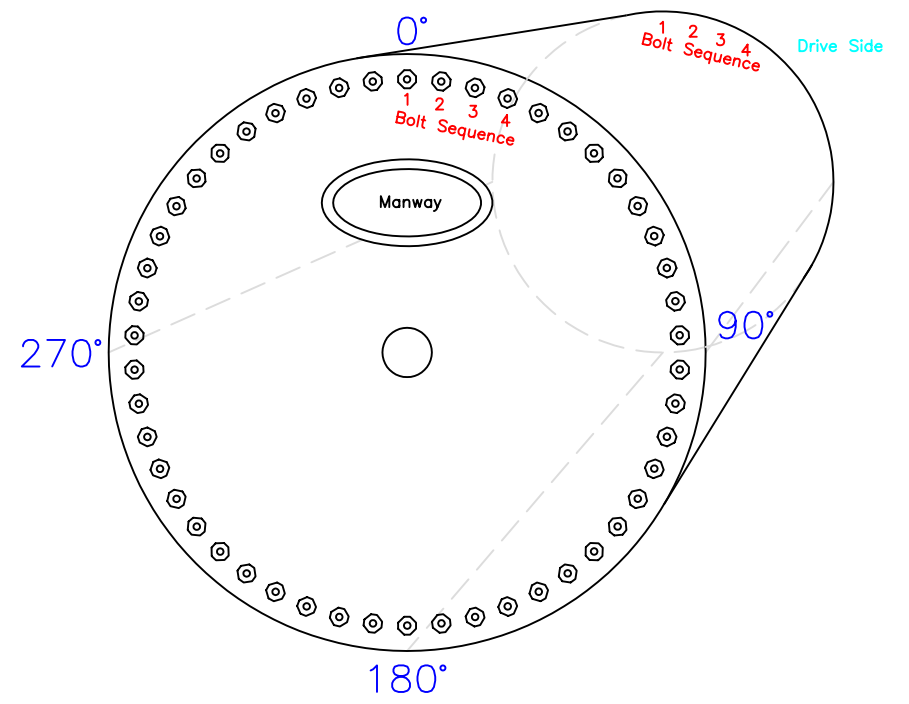
*Tending Side*

**Ultrasonic soundness bolt inspection:** Indication on tending-side bolt #23.

**Recommendations:**  
 Replace/re-rate dryer as necessary.  
 Replace tending side bolt #23
